Manhole Inspection Summary

Manhole # S11CC2021MH

Insp Date: **7/28/06 9:17 AM**

Location Address: **5707 OAKSHIRE RD**

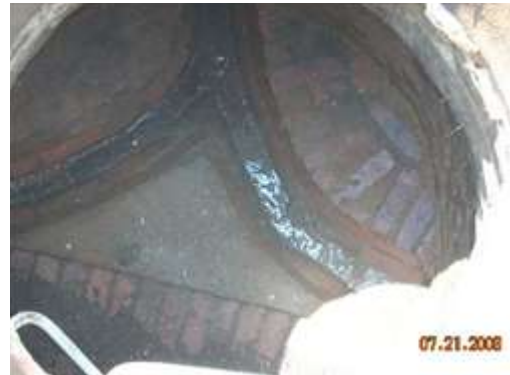
Top View

Evidence of surcharge - Bench debris.
Channel debris.

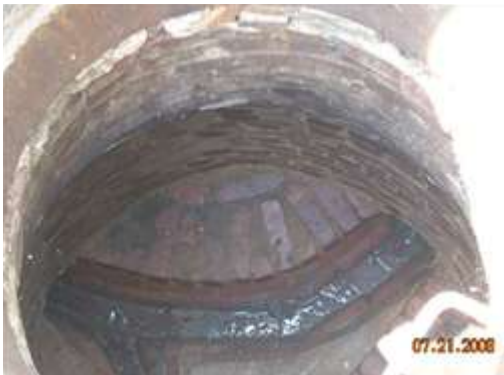
Defect

Frame leaks. Adjustment deterioration,
loose brick and infiltration. Corbel and
Barrel infiltration.

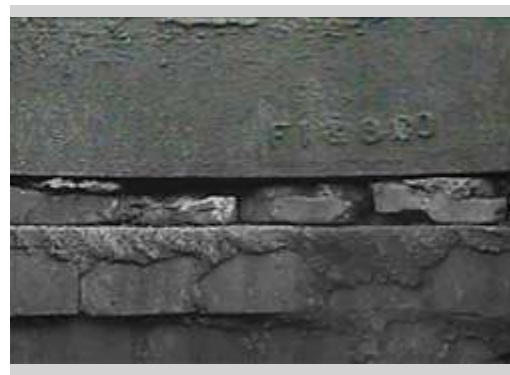
Defect

Frame leaks. Adjustment deterioration
and infiltration.

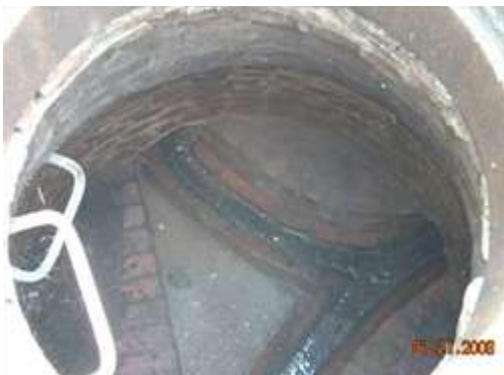
Defect

Frame leaks. Adjustment deterioration,
loose brick and infiltration. Corbel and
Barrel infiltration - other side.

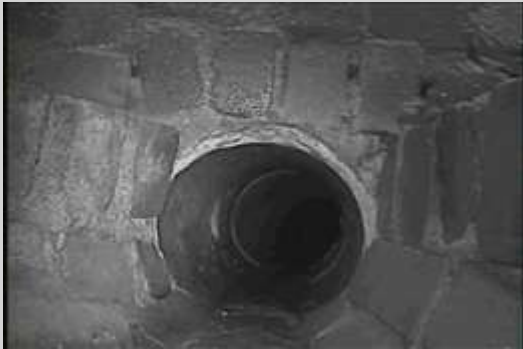
8 in. Circular Gravity Sewer Pipe Out @ 12 O'Clock

Infiltration: **Evidence** Pipe Seal Cond: **Unknown**

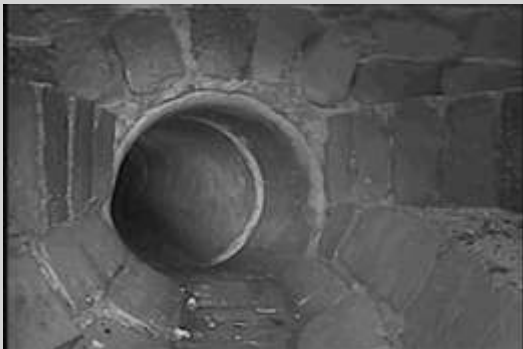
8 in. Circular Gravity Sewer Pipe In @ 4 O'Clock

Infiltration: **Evidence** Pipe Seal Cond: **Unknown**

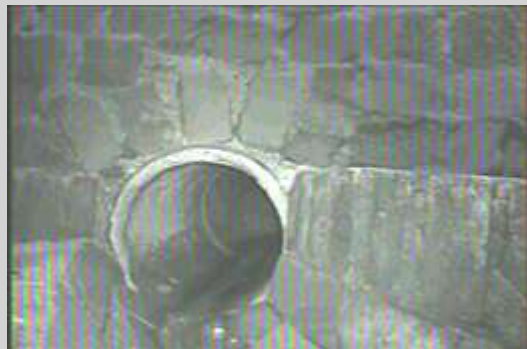
Pipe In @ 8 O'Clock

Channel deterioration.

Infiltration: **Evidence**
